GATEWAY GARDENS HOUSING

FY 2022 – 2023

RENOVATION PLAN

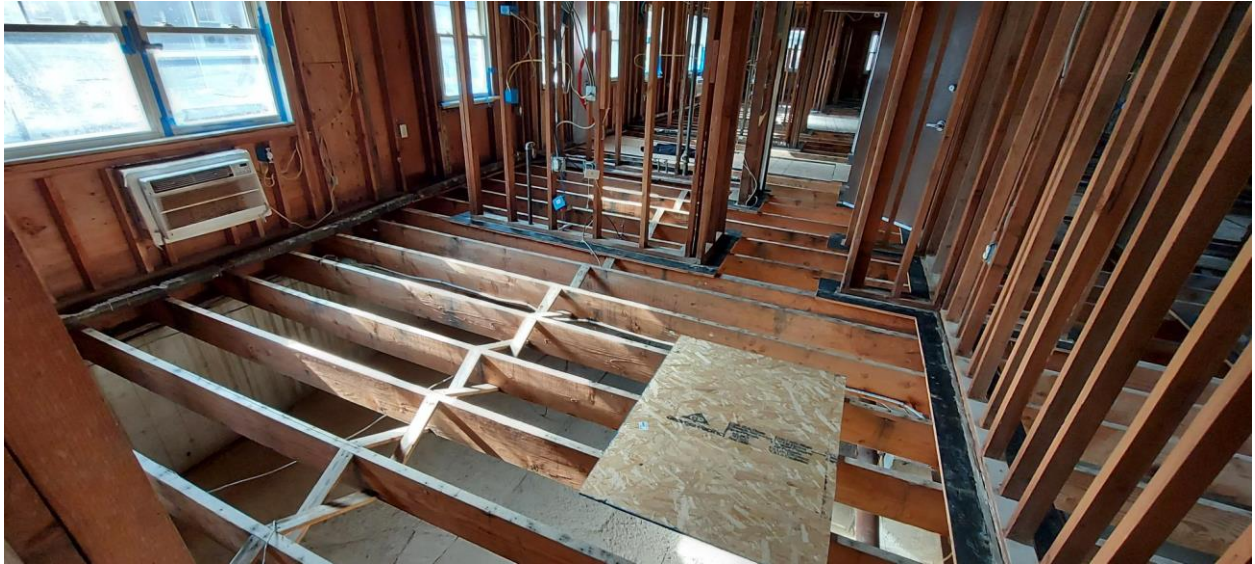
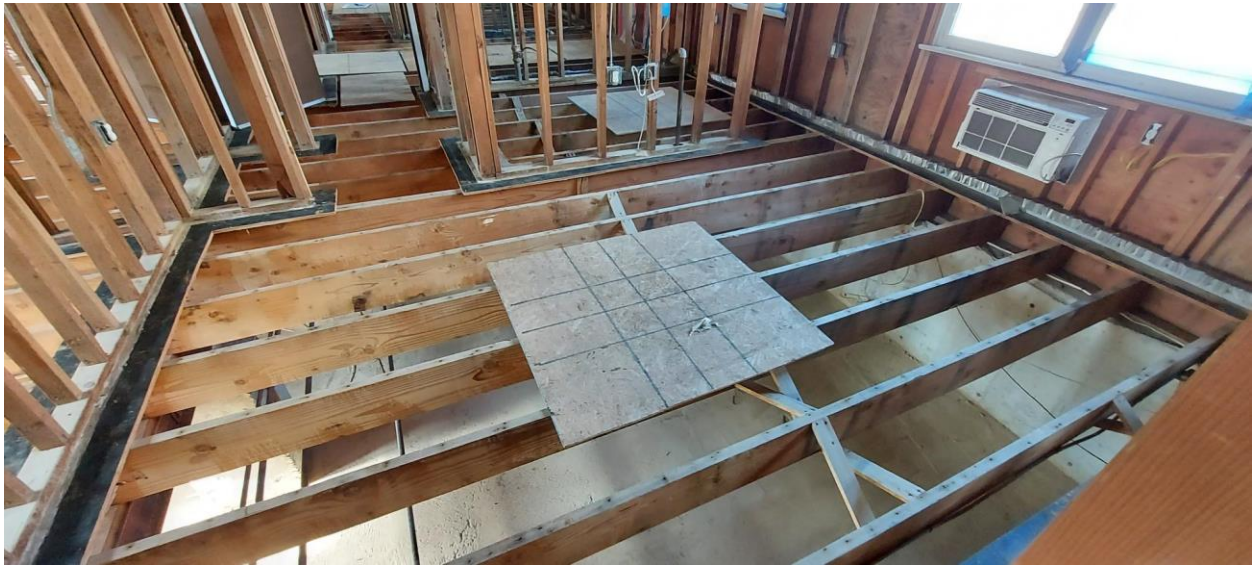
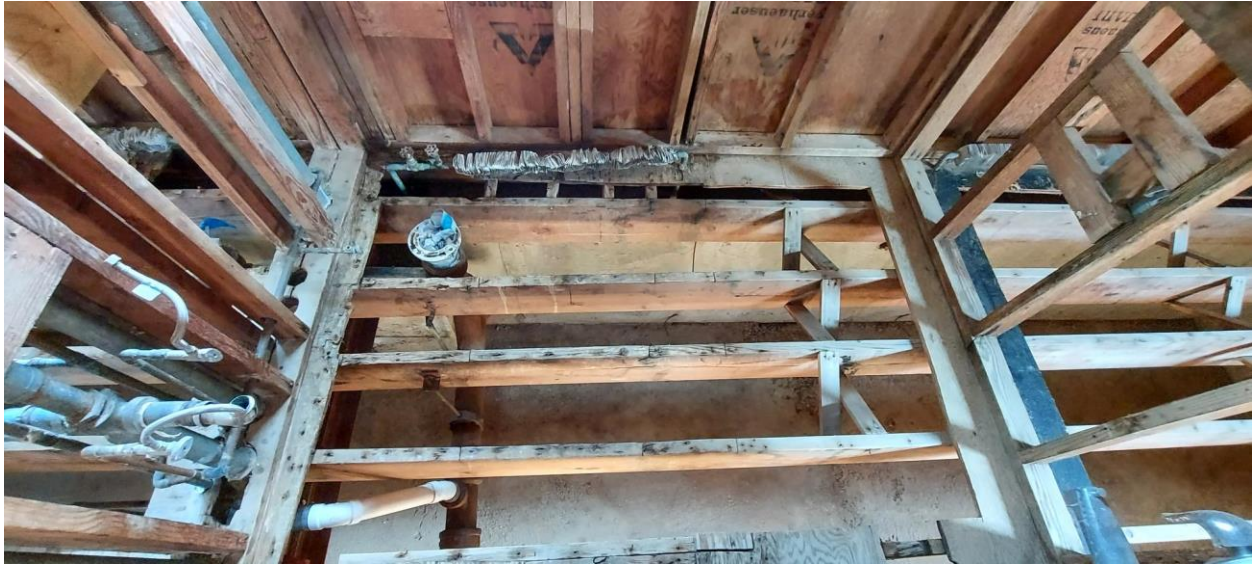
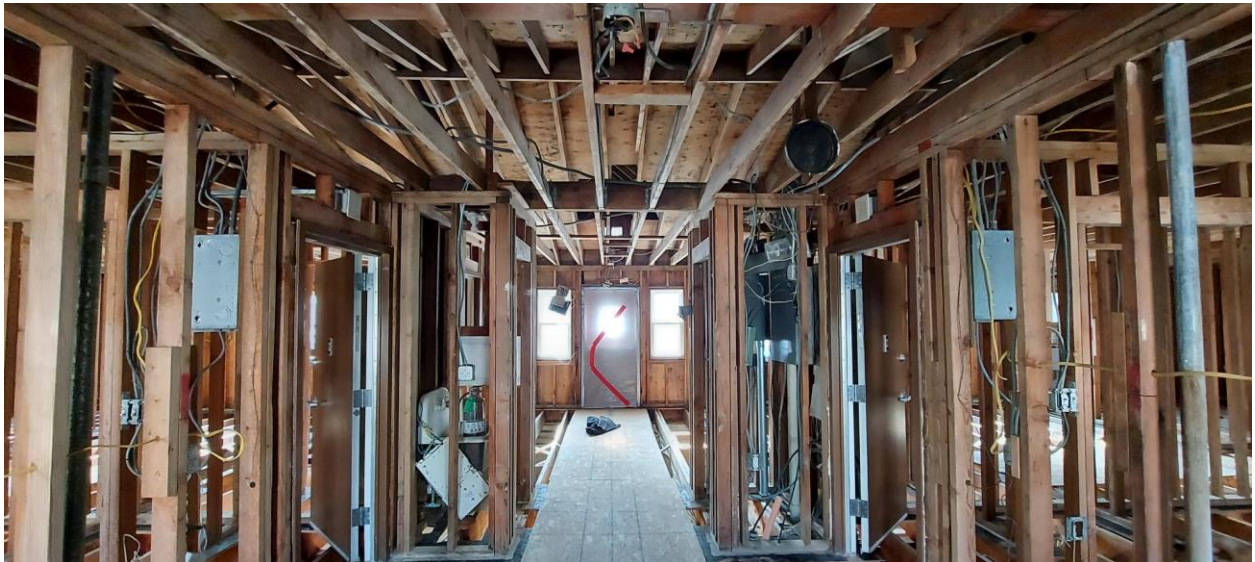
- On March 2, 2022 BBS Architect/Engineer came on-site to begin measuring and surveying existing conditions. See pictures of what they viewed.
- On March 2, 2022 BBS Architect/Engineer provided a letter with some observations/recommendations. The thermostat and running water was corrected by in-house maintenance staff as soon as possible
